EVALUATION OF A HYDROHANDLING SYSTEM FOR SORTING AND SIZING APPLES FOR STORAGE IN PALLET BOXES

Marketing Research Report No. 948

**Agricultural Research Service
UNITED STATES DEPARTMENT OF AGRICULTURE
In Cooperation With
Michigan State University Agricultural Experiment Station**

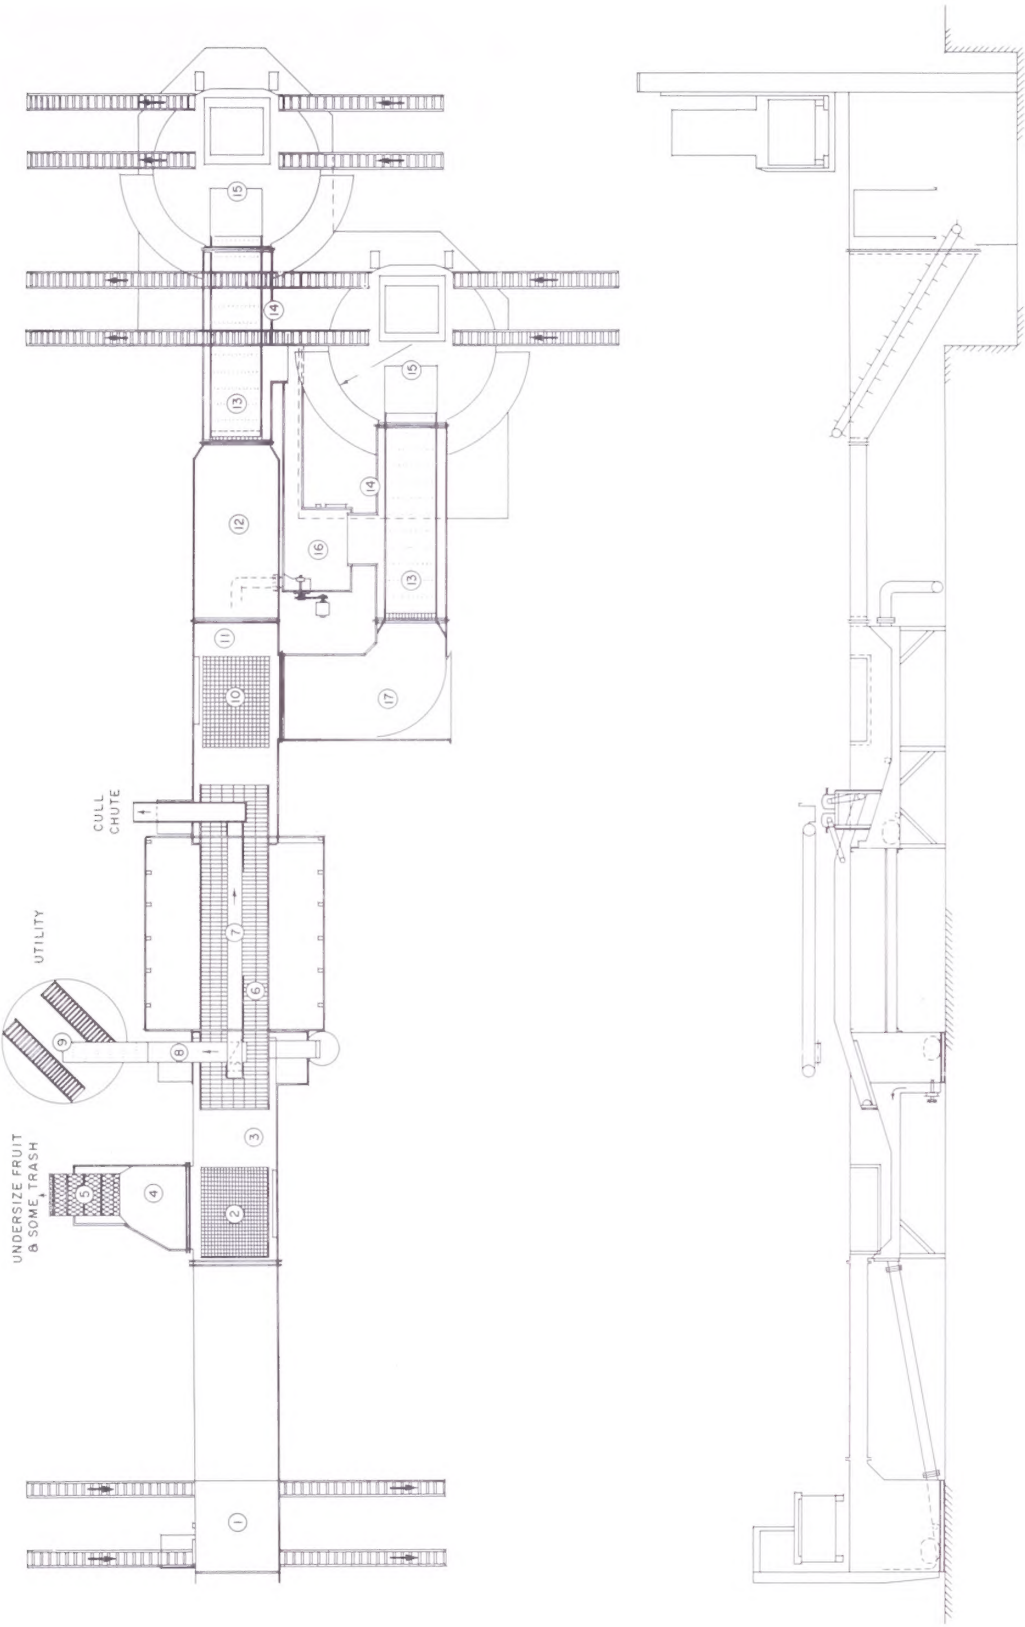
FIGURE 1.—Prototype hydrohandling system showing (1) flotation dumper, (2) hydroeliminator, (3) continuation of dumper tank, (4) lateral flume, (5) flight conveyor, (6) roller sorting table, (7) utility and cull conveyor, (8) dry pallet box filler, (9) hydrosizer, (10) hydrosizer tank, (11) hydrosizer tank, (12) main flume, (13) submerging conveyors, (14) tanks for submerging conveyors, (15) hydrofillers, (16) storage tank for water, and (17) lateral flume.

The purpose of this hydrohandling system is to size and sort apples at a rate up to 600 bushels per hour before placing them in storage. The apples arrive from the orchard in pallet boxes and need to be sized, sorted, and returned to pallet boxes with a minimum of hand labor and bruise damage. The hydrohandling system was described in detail by Stout et al. (9) in 1966. The major components are a flotation dumper, a hydroeliminator, a roller sorting table, a hydrosizer, and two hydrofillers (figs. 1 and 2).

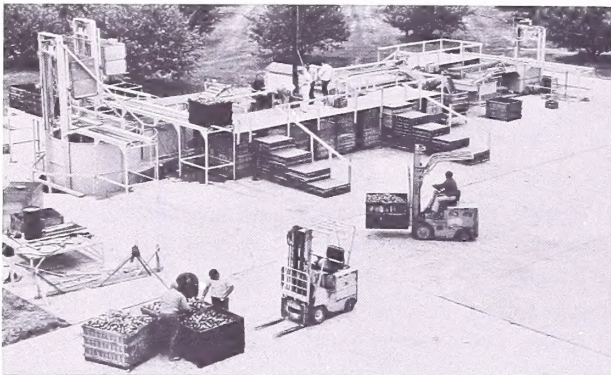
BN-27778

FIGURE 2.—The prototype hydrohandling system. The platforms along the sides were built for observation of tests.

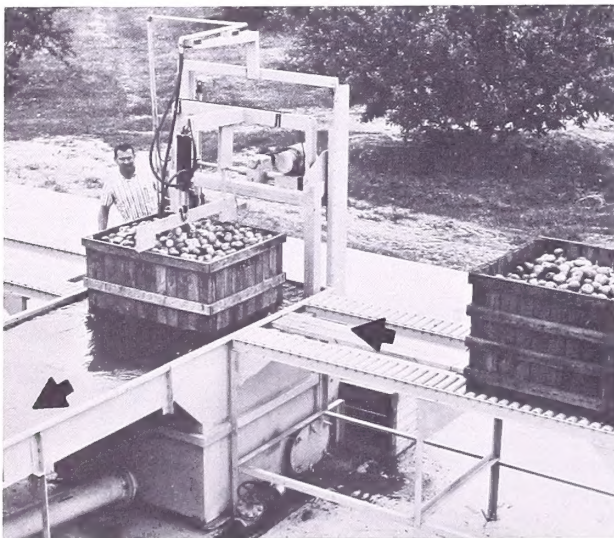
BN-27779

FIGURE 3.—A pallet box of tree-run (unsorted) apples being submerged by the flotation dumper.

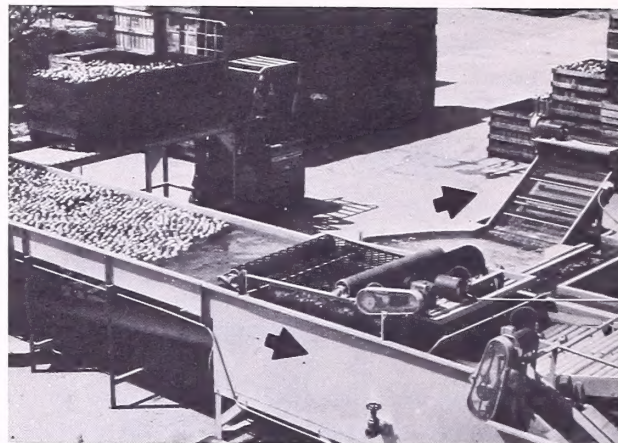
BN-27781

FIGURE 4.—The hydroeliminator at the end of the flotation dumper tank.

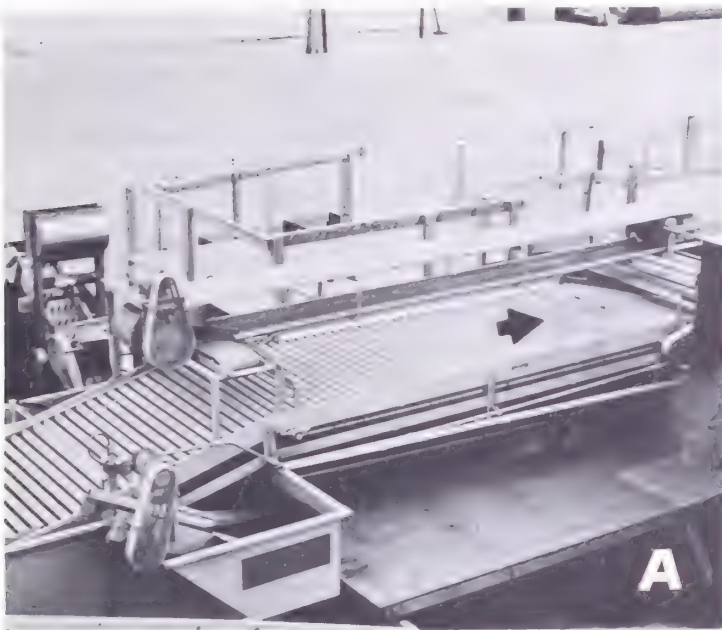
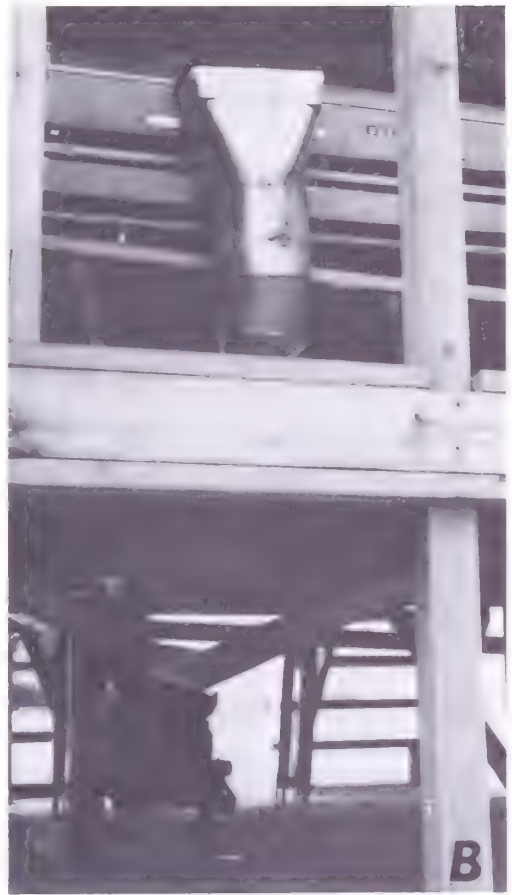
BN-27783 BN-37537

FIGURE 5.—(A) The roller sorting table (lanes were installed later). Utility apples are placed on lower belt above the table and are carried off by a cross-conveyor to a conventional dry pallet box filler (at left rear). Cull apples are placed on the upper belt and are diverted to a gravity chute (not visible in picture) at the end of the sorting table. (B) Cull chutes were added at sides of roller sorting table to increase efficiency of workers.

Workers sorting apples stand on wooden platforms at the sides of the sorting conveyor. The defective fruits are placed on a utility and cull conveyor, which is a closed loop belt above the sorting table. The lower belt is for utility apples which are transferred from the belt to a conveyor and to a dry pallet box filler which places the apples in a pallet box. The cull apples are diverted from the cull belt to a gravity flow chute leading into a pallet box. Cull chutes were provided at the sides of the table to increase the capacity and efficiency of the workers.

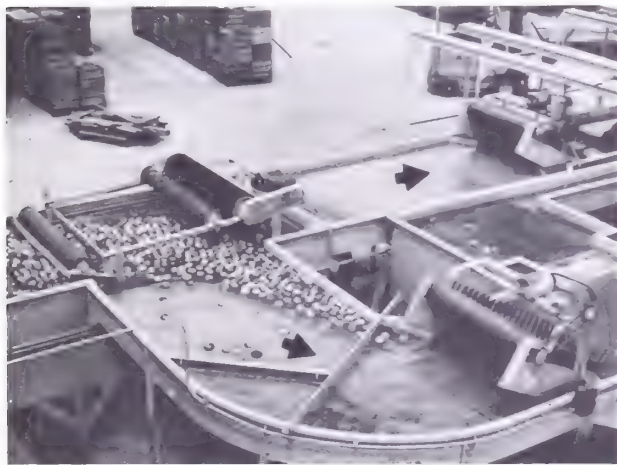
BN 785

FIGURE 6.—The hydrosizer. Apples are returned to water from the sorting table for separation into two sizes by the hydrosizer.

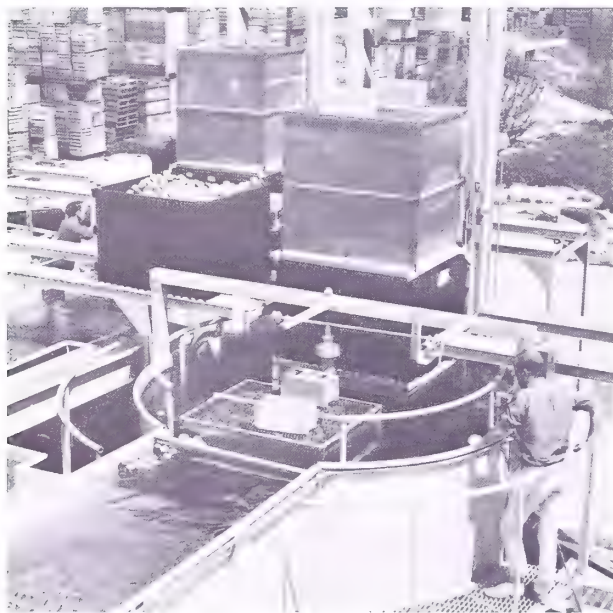
BN-27786

FIGURE 7.—The accumulator of the hydrofiller in the foreground is being filled with apples by the submerging conveyor. The second accumulator has been lifted from the water tank, together with a pallet box. The fruit is transferred to the box as it is raised above the water surface. (Grills and blocks were placed on the accumulators for testing.) A previously filled pallet box is shown to the left on a set of roller conveyors.

feet in diameter and 8 feet 10 inches deep. The submerging conveyor carries the apples down into the water and allows them to float up into the accumulators. Each accumulator is 36 inches wide, 44 inches long, 50 inches high, and has a capacity of 25 bushels. While in the tank, the accumulators rest on a frame mounted on a spindle that permits 180° rotation.

The lift mechanism, similar to the lift on the hydrodumper, is mounted opposite to the submerging conveyor in the tank. This lift submerges a pallet box beneath the accumulator in the tank.

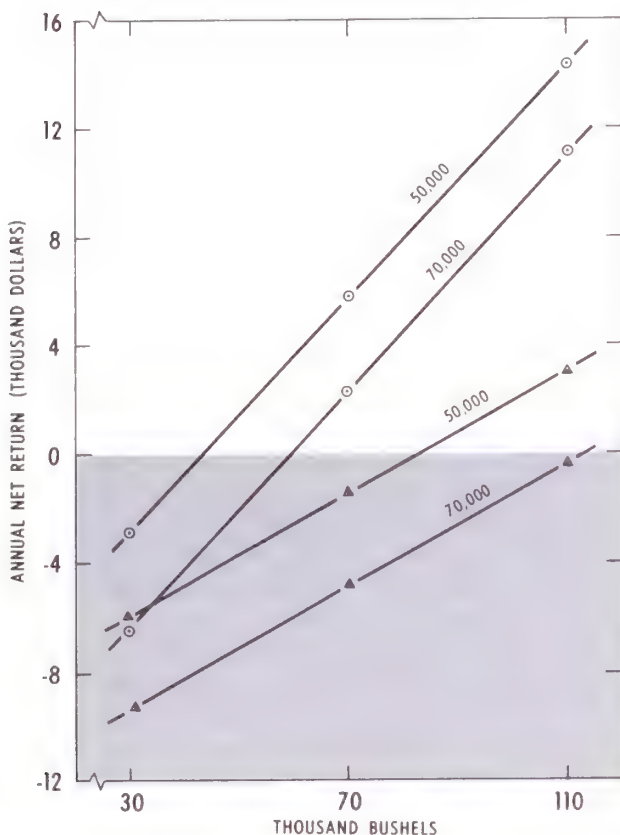
FIGURE 8.—The projected effects of gradeout percentages, initial cost of equipment, and total volume of fruit on annual net return from prestorage sizing and sorting of apples, with 50 percent each of Jonathan and McIntosh supplied at 300 bushels per hour and sized and sorted with an efficiency of 65 percent.

○: gradeout of 70 percent as U.S. No. 1 or better grade, 20 percent as U.S. Utility grade, and 10 percent as culls.

The effects of gradeout percentages and cost of the system (fig. 8) show that as the apples of higher quality are used the net return decreases. This is an important factor to consider when the apples arrive at the storage plant. A quick check on quality should be made to determine whether potential gradeout is high enough to justify the operation. As the initial cost of the equipment increases, the projected net return decreases.

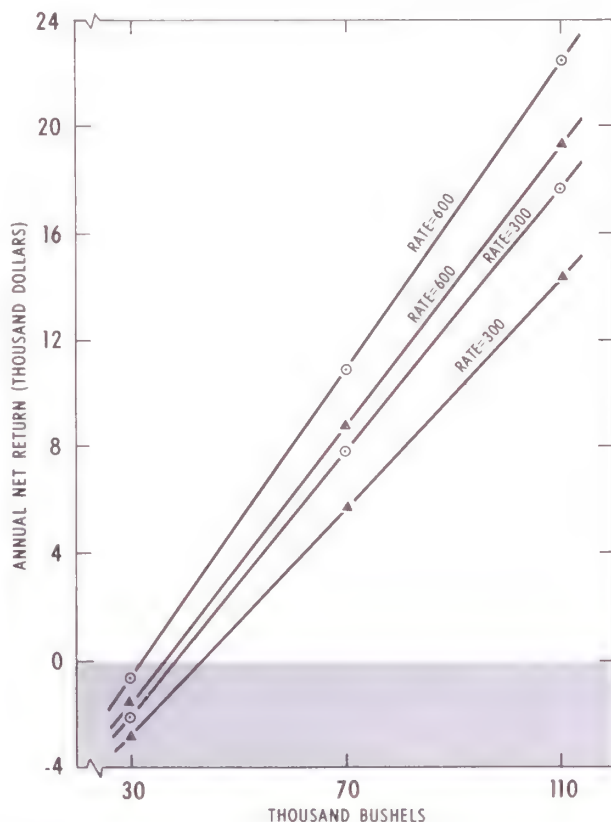
FIGURE 9.—The projected effects of sizing and sorting efficiency, operating rate, and total volume of fruit on annual net return from prestorage sizing and sorting of apples, with 50 percent each of Jonathan and McIntosh, having a sortout of 70 percent U.S. No. 1 or better, 20 percent U.S. Utility, and 10 percent culls using equipment of an initial cost of \$50,000.

○: sizing and sorting efficiency of 65 percent.

Figure 9 shows that higher efficiencies of sizing and sorting will yield a greater net return for the operation. This is due to the increases in savings on storage costs and potential storage gains due to the value increase of the fruit during storage. Increased operating rates also increase net return, especially as the volume of the apples is increased.

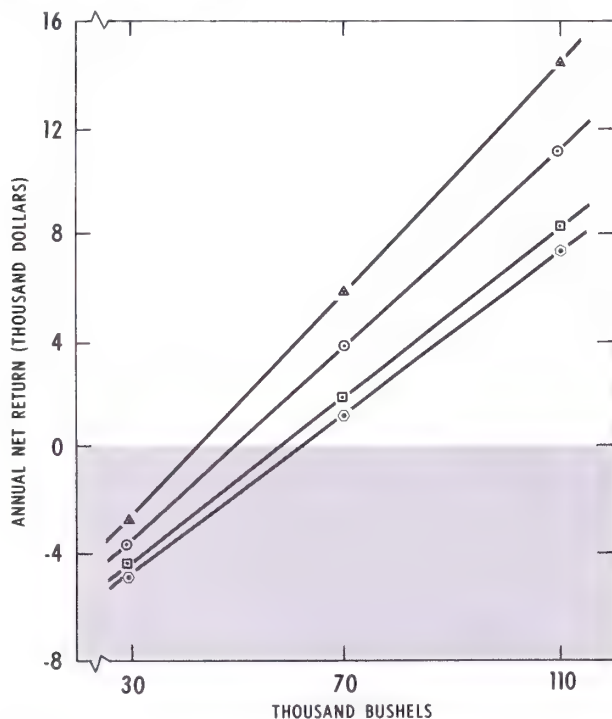
FIGURE 10.—The projected effects of mixture of varieties and total volume of fruit on annual net return from prestorage sizing and sorting of apples, with a sizing and sorting efficiency of 65 percent, a sortout of 70 percent U.S. No.1 or better grade, 20 percent U.S. Utility grade, and 10 percent culls, and a rate of 300 bushels per hour using equipment with an initial cost of \$50,000. Mixture of varieties, in percent:

Symbol on figure	Delicious	Jonathan	McIntosh
○	25	30	45
△	0	50	50
□	50	0	50
◇	50	50	0

The mixture of varieties of fruit utilized in the system affects the net return (fig. 10). The Jonathan and McIntosh varieties are more likely to justify prestorage sizing and sorting because their increase in value for U.S. No. 1 and better grades is greater than for Red Delicious (table 1).

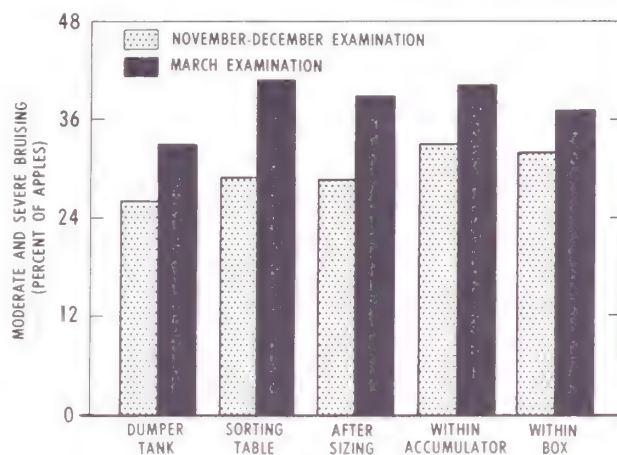
FIGURE 11.—Relative total bruising damage to apples removed from hydrohandling system at various points and held in cold storage in 1967-68.

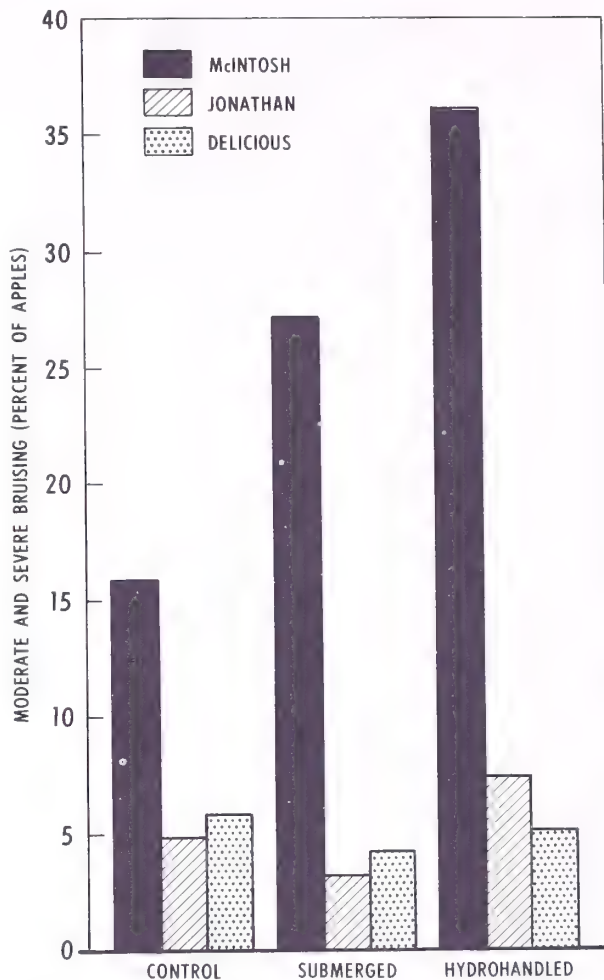
FIGURE 12.—Bruising damage to apples after C.A. storage in relation to prestorage handling treatment and variety in 1967-68.

McIntosh apples were seriously damaged by bruising as a result of submerging and hydrohandling (fig. 12), whereas the Jonathan and Delicious apples were not. Damage to McIntosh by all of the treatments exceeded the corresponding treatments of the other two varieties by highly significant amounts. Control (untreated) McIntosh had approximately 16 percent of the fruit damaged by bruising; to this, the relatively careful submerging treatment in the enclosed pallet box increased the number of damaged apples by approximately 11 percentage points. The hydrohandling system caused an increase of 20 percentage points in bruising over the control so that over 36 percent were found to be damaged when the apples were dumped after removal from storage. The maximum percentage of bruised apples for Jonathan was 7.5 percent, for Delicious slightly less than 6 percent. For these varieties, there were no significant treatment differences.

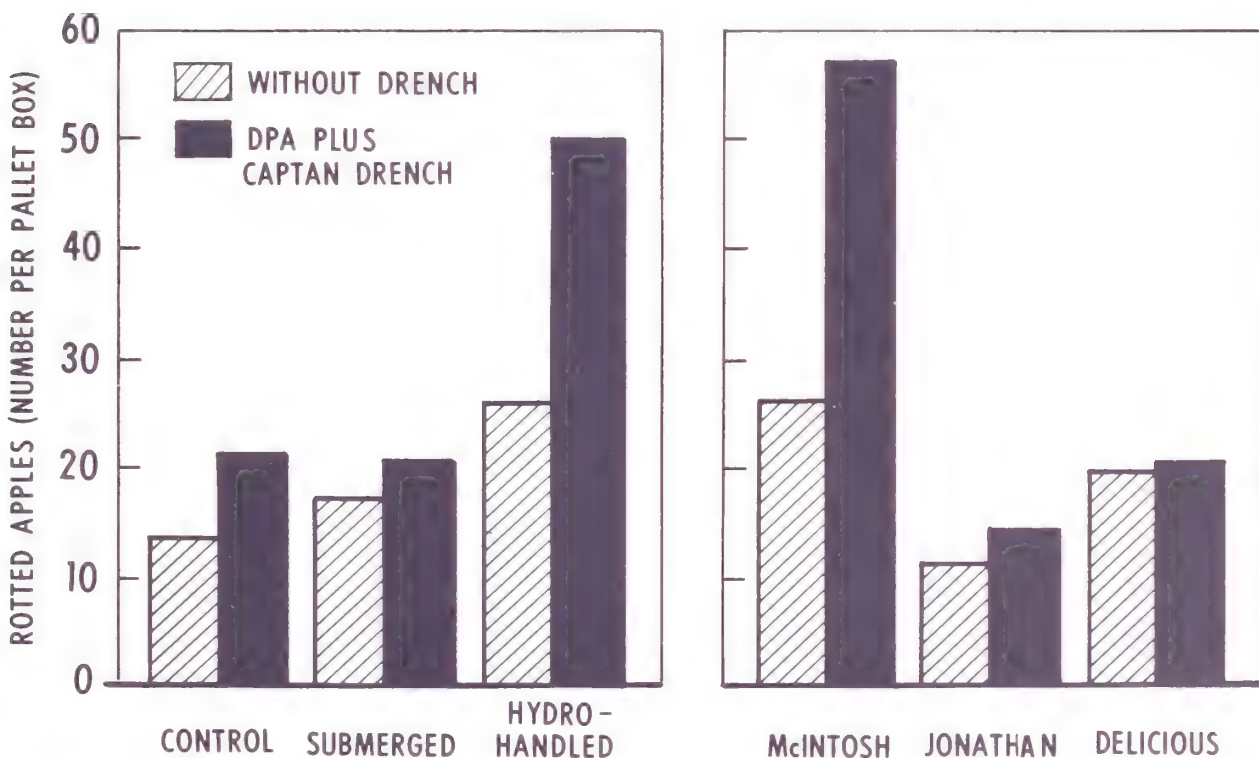
FIGURE 13.—Relative number of apples developing rot during C.A. storage as affected by handling treatment and variety in 1967-68.

The relative amounts of fruit rot as determined by count of affected apples per bin are plotted for varieties and handling treatments in figure 13. Hydrohandling caused a highly sig-

nificant increase in fruit rot over submerging and control (fig. 13, left), whereas the submerging and control treatments were similar. For varieties (fig. 13, right), McIntosh exceeded the others by highly significant amounts. Jonathan and Delicious did not differ in decay. Drenching the fruit with a DPA and captan solution increased rotting of apples over those which received no drench treatment; apparently, the captan was of inadequate strength to prevent a buildup of viable disease inoculum in the drench solutions. Significant interactions occurred for "Handling treatments \times Drench treatments" and for "Variety \times Drench treatments" (fig. 13). As previously shown for bruising, the McIntosh apples were particularly susceptible to rot after passing through the hydrohandling system.
